TECHNICAL BULLETIN

No: LS-414-001

Battery Junction Box Connections

Range Rover Sport (LS)

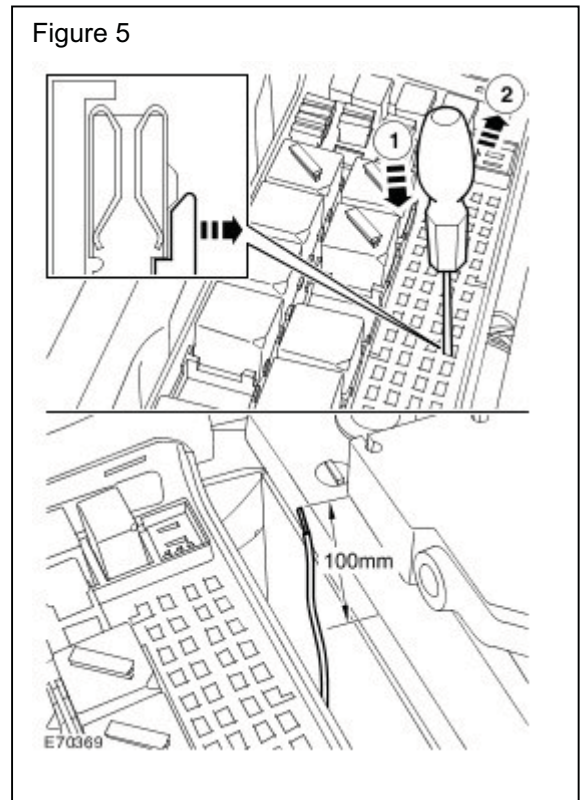
Figure 5

10. If the fuse terminal is damaged or the fuse is not held securely when inserted, replace the damaged terminal as follows:

- Using special tool YRW500030 from the harness repair kit, release the damaged terminal from the aperture by disengaging the terminal securing tang and pulling the wire/terminal from the underside of the fuse box. (Figure 5)
- Cut the terminal wire approximately 100mm (4 inches) from the terminal. (Figure 5)
- Place a piece of heat-shrink wiring insulation over the cut wire and move aside.
- Using the new terminals supplied with the repair kit (YPL900310 - 2.5mm blue wire – SPX Reference 418-587-14), splice the new terminal wire to the cut wire.
- Position the heat shrink insulation over the wiring joint and apply heat to shrink the insulation.

CAUTION: Ensure correct terminal orientation. The terminal location pegs must align with the terminal aperture slots.

NOTE: A positive location must be achieved and the wire must be retained once it is inserted.
